USAAVLABS TECHNICAL REPORT 68-82

DEVELOPMENT OF A CRASH-RESISTANT FLAMMABLE FLUIDS SYSTEM FOR THE UH-1A HELICOPTER

S. Harry Robertson

January 1969

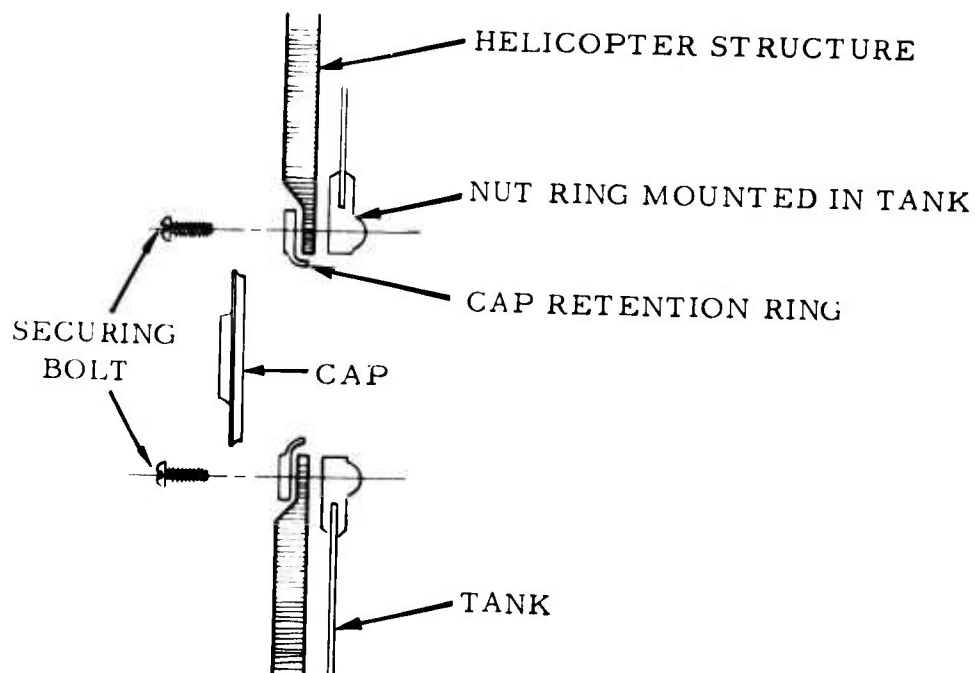
Figure 17. Filler Neck Attachment (Original Design).

The new crash-resistant cells were manufactured to take advantage of the existing fuel filler opening in the helicopter skin. The same filler cap and the accompanying hardware into which the cap is normally secured were used for the modification. A more beneficial attachment method was used. The original method, Figure 17, sandwiched the helicopter structure between the cap retention ring and the fuel cell. It also used a total of six bolts. The new method, Figure 18, attached the cap retention ring directly to the tank and attached a frangible ring to the retention ring. The same six bolts served both these functions. The frangible ring was then, in turn, attached to the helicopter structure. This required six additional bolts.

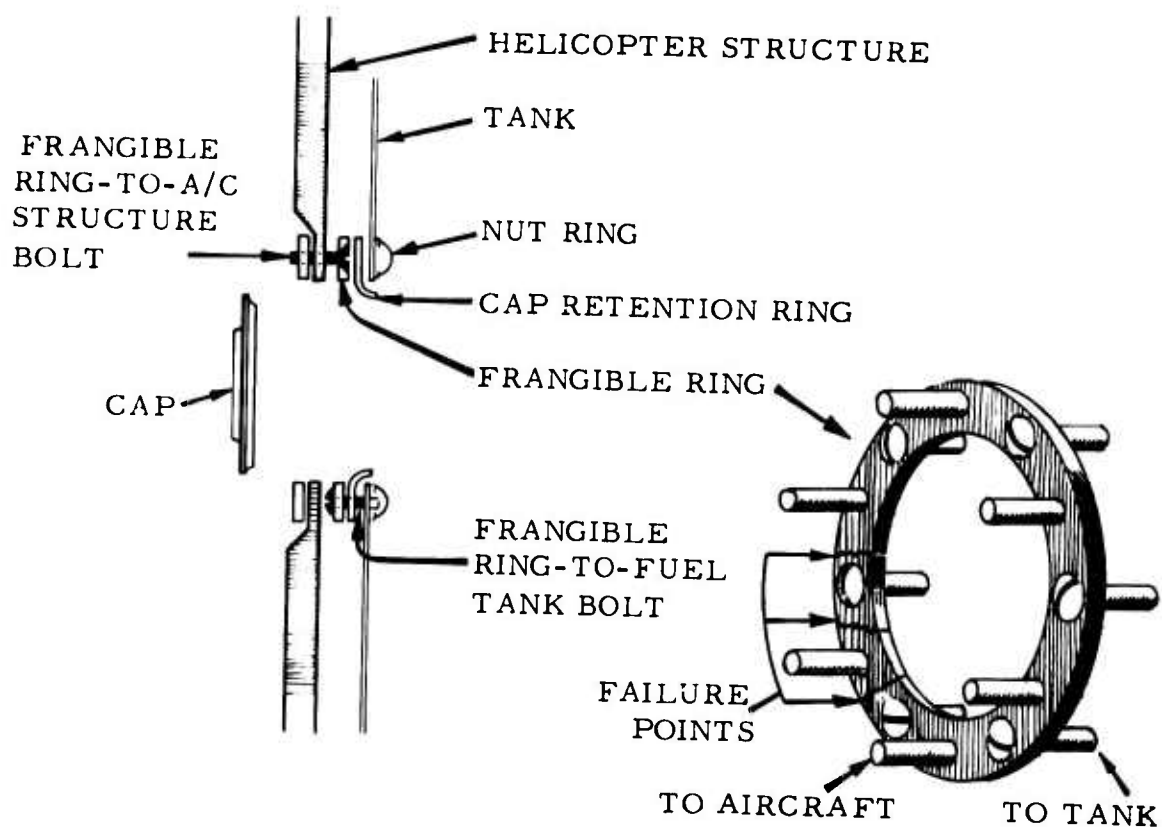
Figure 18. Filler Neck Attachment (Crashworthy Design).

The modification allowed the filler cap to remain with the tank, preventing spillage; whereas the earlier design kept the cap with the fuselage, thereby insuring spillage.

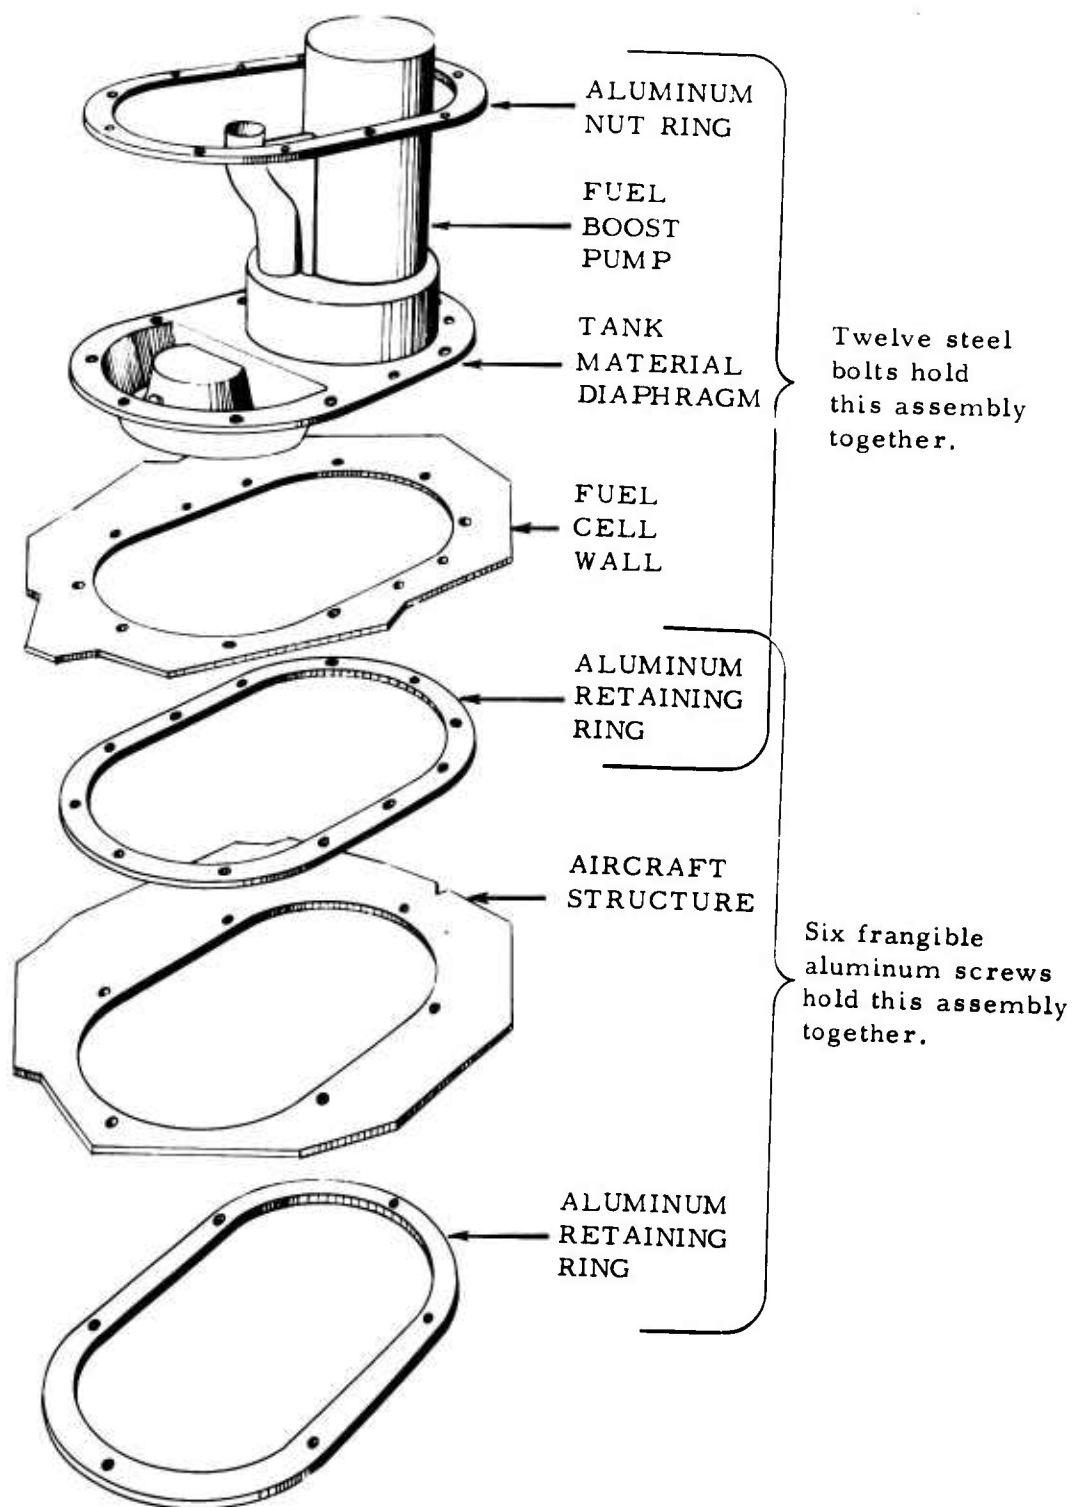
Figure 19. Boost Pump Installation.

The boost pump is normally bolted to a mounting diaphragm, which, in turn, is bolted to the tank. The pump and mounting diaphragm assembly are secured to the tank and to the helicopter airframe with the same bolts. When displacement occurs between the tank and the helicopter, the mounting diaphragm usually is torn from the tank. This hazardous situation was reduced considerably by installing the diaphragm in the tank with one set of bolts and by attaching the diaphragm to the helicopter with frangible screws. Figure 19 illustrates how this was accomplished.

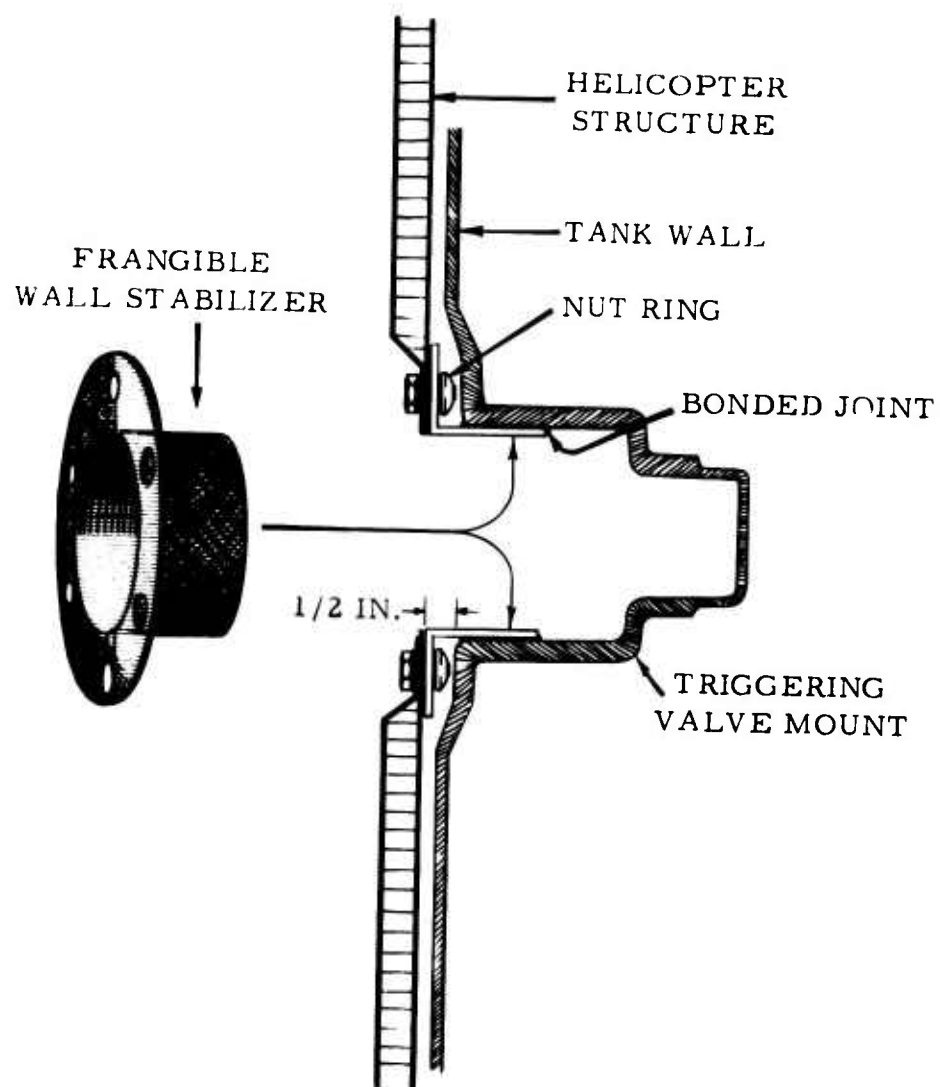
Figure 21. Frangible Fiber Glass Wall Stabilizer.

Since all rigid attachments between the fuel tank and the airframe were potential tank failure points, this installation required modification. Frangible tank wall stabilizers were made of fiber glass and inserted into the tank triggering valve mounts (Figure 21). The stabilizers were bonded into the valve mount and bolted to the airframe through the original stabilizer holes. No modifications to the helicopter were required. The fiber glass stabilizers were capable of carrying full flight loads, yet failed at loads approximately one-sixth that required to fail the tank.

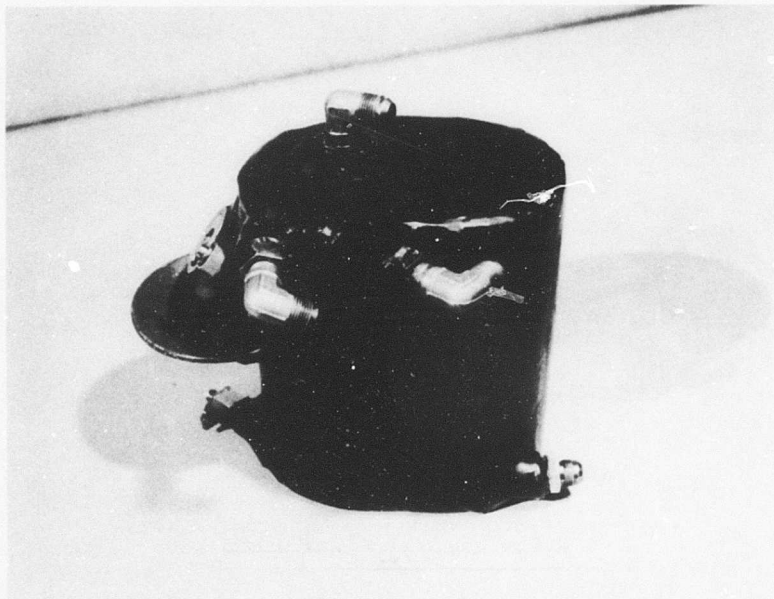
Figure 23. Oil Reservoir With Crash-Resistant Covering.

The oil reservoir was removed and sheathed in a tight, form-fitting, 1/2-inch-thick felt covering; see Figure 23. The purpose of the felt was twofold: (1) it would readily change its contour to cover any shape that the metal reservoir might assume during a crash, and (2) it would soak up any oil that might spill into the felt from a failure in the metal reservoir. The felt was coated on its external surface with a polyurethane resin to make the sheath liquid-tight, to enhance the fire-resistant properties of the felt, and to prevent the external surface from functioning as a wick if the felt soaked up any spilled oil.

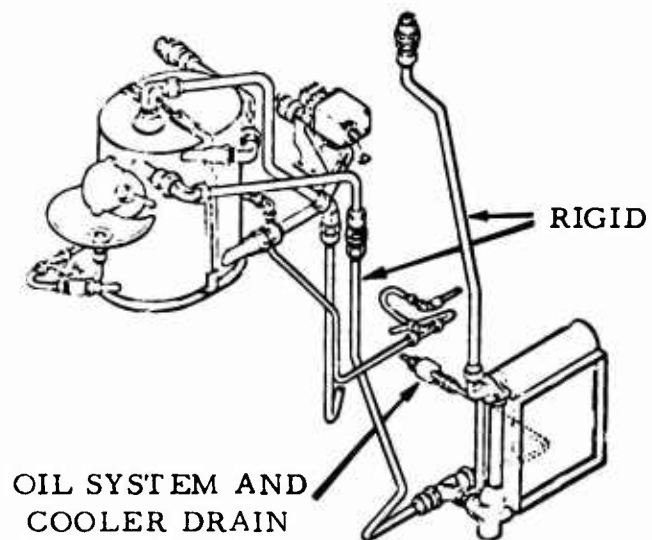
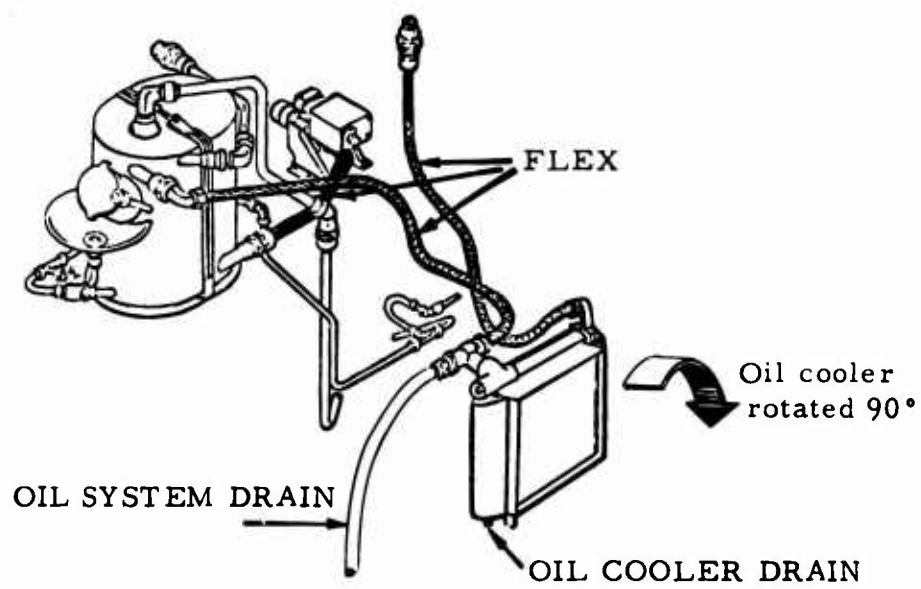
Figure 24. Oil Cooler Modifications.

The standard UH-1A oil cooler installation placed the inlet and outlet fittings on the side of the cooler (Figure 24). In this position, the lower oil return line and fitting were extremely vulnerable to crash damage caused by the upward displacement of the

airframe structure and the aft landing gear crossover tube. The cooler was rotated 90 degrees, placing the inlet and outlet fittings on top of the cooler as shown in Figure 24. The oil cooler could still be drained by using a conveniently located extra hole in the cooler.

1. The oil cooler had been rotated 90 degrees in position to place the inlet and outlet fittings on top of the cooler away from possible strike damage on the right side, as shown in Figure 24.
2. The cooler-to-engine line passed through the service deck by means of a self-sealing quick disconnect. This valve was secured in a stainless-steel triggering valve mount that was installed flush with the top of the service deck. The line was included in the drop test to determine if the inertial mass of the valve body would cause valve separation under high vertical loading.

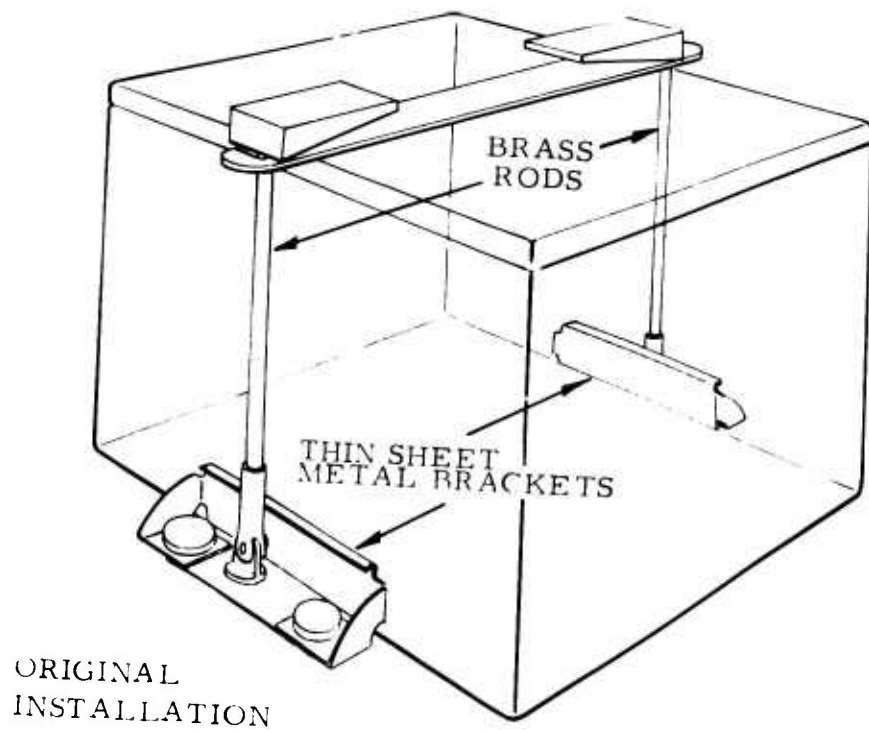
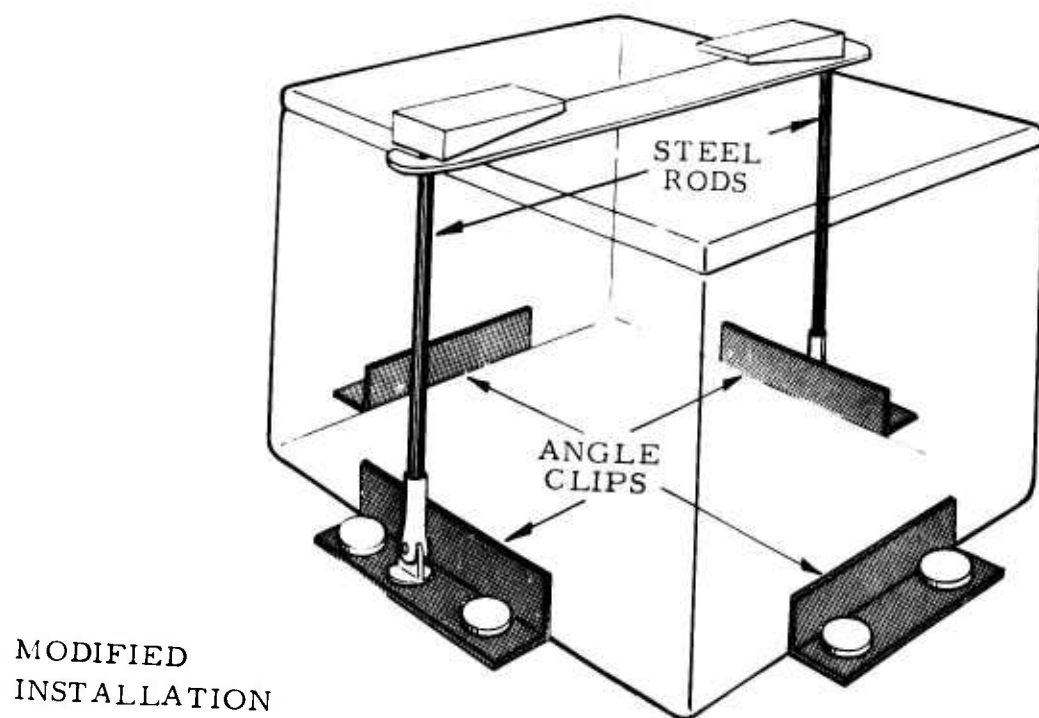
Figure 28. Battery Installation.

To reduce the probability of release, the two retainer brass tiedown rods were replaced with steel rods. The two thin sheet-metal restraint brackets (see Figure 28) were replaced with four 6-inch-long aluminum angle clips. The four clips were bolted to the compartment shelf on which the battery was located.

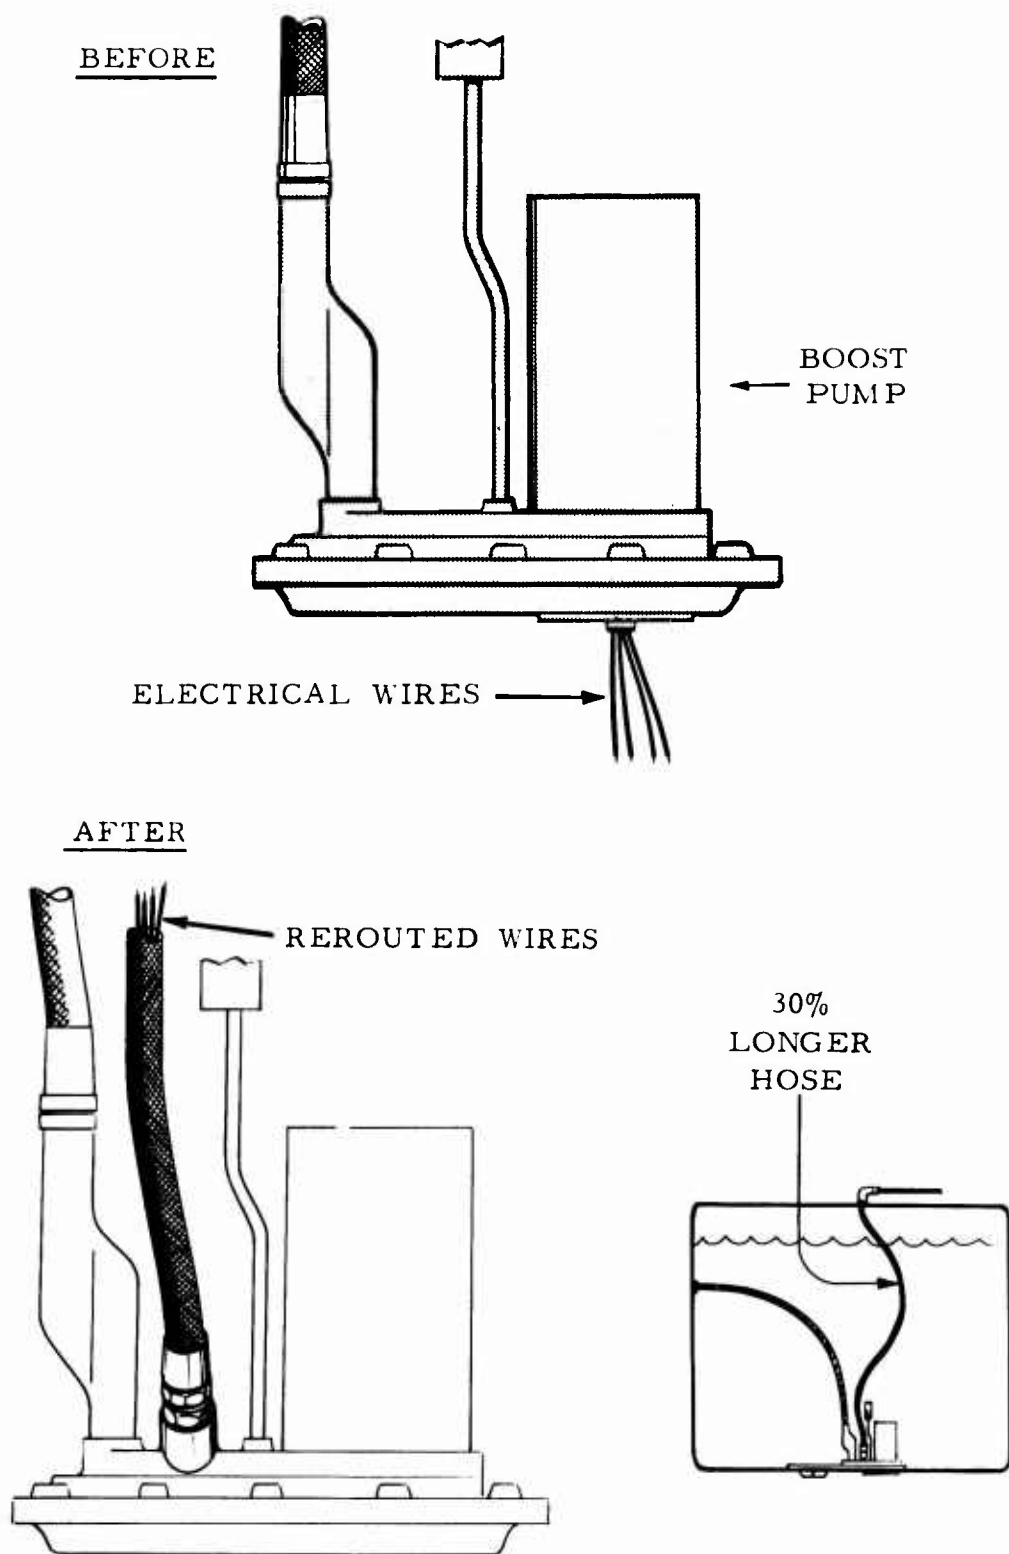
Figure 29. Boost Pump Modification.

The electrical wires normally exited the boost pump at the bottom of the fuel tank. Structural collapse in this area would allow the boost pump wires to be cut or broken. Abrading action of the underbelly's sliding across the terrain could also damage these wires and thus provide an ignition source. The original boost pump wire routing was particularly hazardous because it placed electrically energized wires in an area in which crash-induced fuel spillage was likely to occur.

The ignition hazard was greatly reduced by rerouting the boost pump wires. The pump was modified slightly, as shown in Figure 29, to allow the wires to exit inside the tank. The wires then traveled up through the fuel in a standard flexible hose. The hose was approximately 30 percent longer than would be normally required; thus, it could allow the fuel tank to rearrange its volume without placing tension loads on the hose and wires.

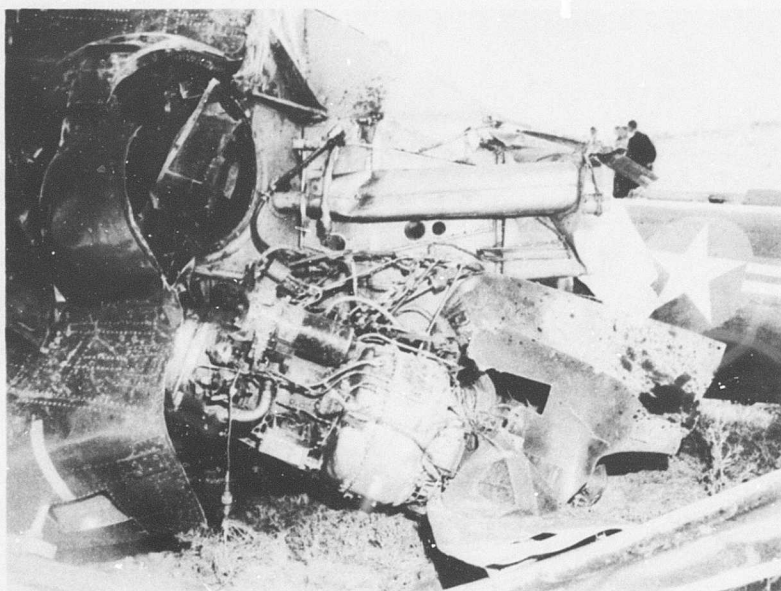
The main rotor blades remained attached to the rotor head. The main transmission, as well as the engine, broke free of all mountings and displaced leftward, as shown in Figures 39, 40, and 41. Most of the cabin roof was torn free, and the fuselage broke, nearly separating, where the aft passenger compartment vertical bulkhead joins the floor; see Figure 42.

Figure 40. Postcrash Position of Engine.

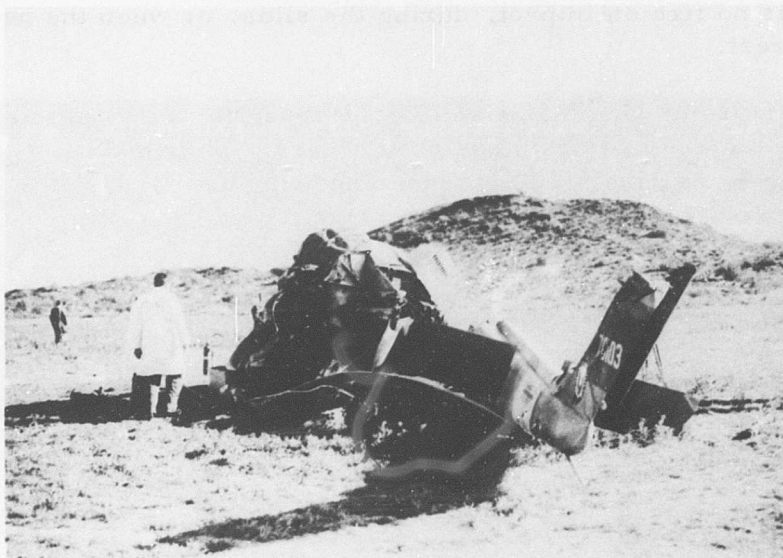
Figure 41. Position of Main Rotor Blades in Wreckage.

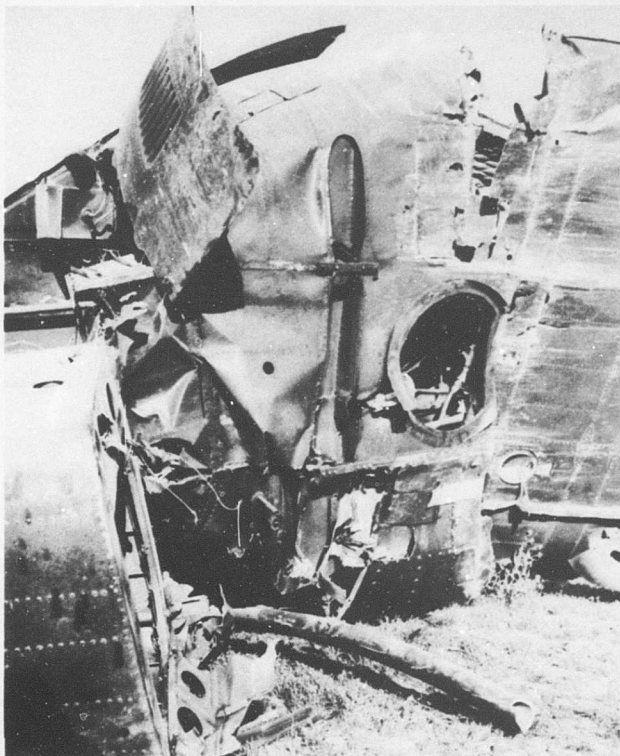
Figure 42. Bottom View of Fuselage Break.

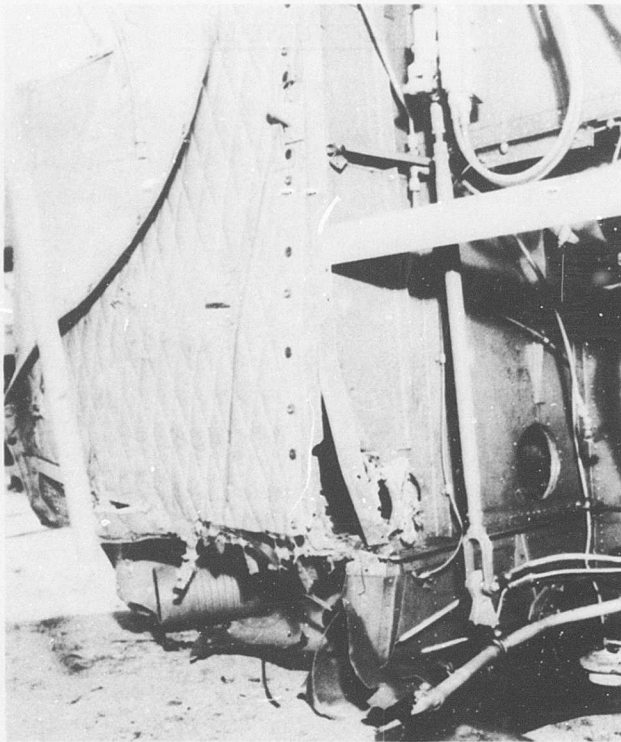
The crash-resistant fuel tanks were not punctured, nor did they release their fuel load at any point. A bottom corner of the right cell was gouged when the supporting structure surrounding it failed and then displaced back and forth against the corner; see Figure 43. No other damage to the fuel cells was discovered. The tank system is shown re-assembled in Figure 44, a photograph taken after the cells were removed from the wreckage.

Figure 43. Deformed Structure and Exposed Fuel Cell.

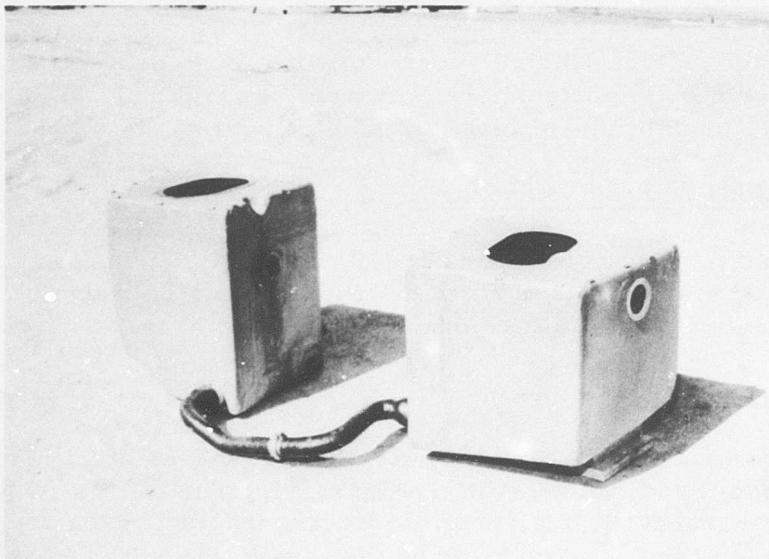
The aft crossover tube, made of flexible crash-resistant material, remained intact and can be seen in Figure 44. The aft tube was not displaced; consequently, the frangible interconnects at each end did not receive the necessary force to make them separate. The forward crossover tube, made of flexible hose, was intact and the valves were still attached to the tank.

Figure 44. Tank System and Aft Crossover Assembly Reassembled After Test.

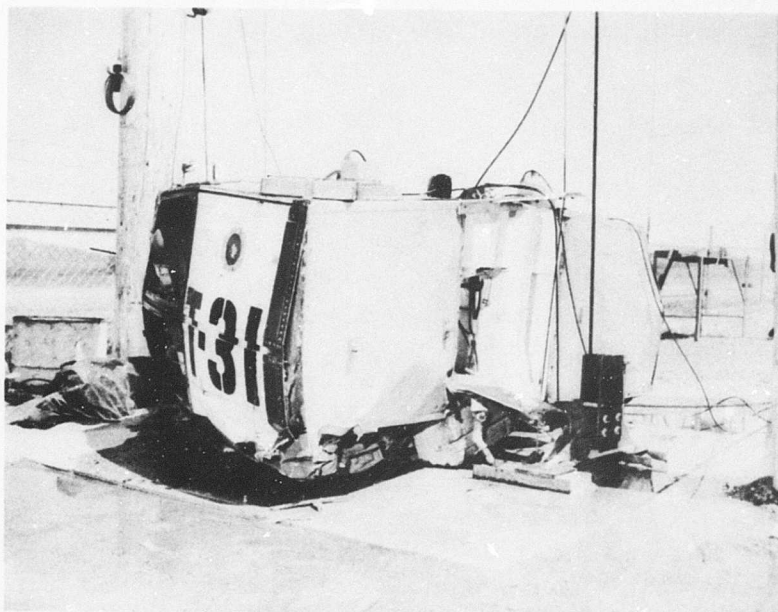
The fuselage section impacted flatly onto the pad, completely enveloping the railroad ties positioned beneath. The posttest position of the section is shown in Figures 96 and 97. The condition of the bottom of the section can be seen in Figure 98. The vertical accelerations recorded atop

Figure 97. Posttest View of Section - Right and Front Sides.

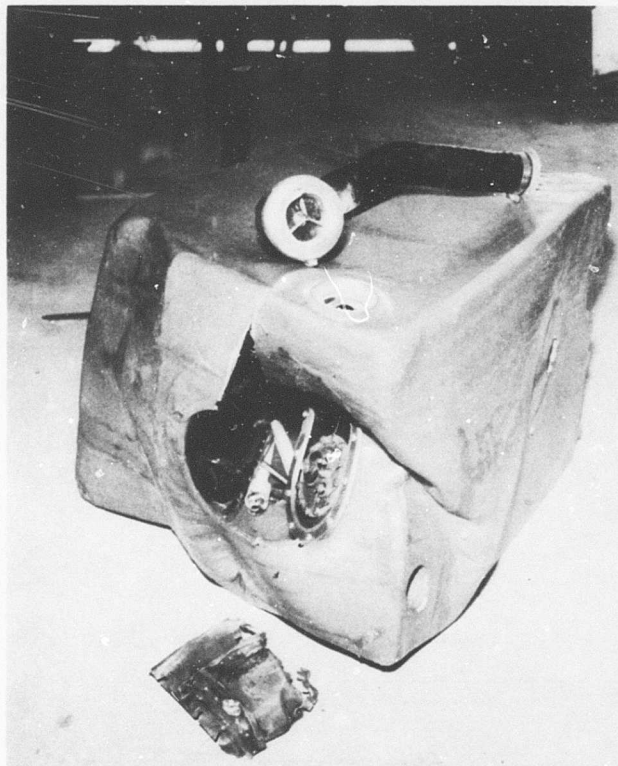
The tie beneath the left fuel cell impacted the boost pump, driving it and the mounting diaphragm upward. A rip in the cell material commenced at the pump opening and ran rearward to the aft bottom edge of the cell. A rip and a large opening were created (Figure 101) as the attaching hardware in the pump mounting diaphragm pulled through the cell material (Figure 102). An interior cell view, showing that the tie penetrated the cell and that the electrical power leads to the pump were not damaged in their protected position inside the flexible hose, is shown in Figure 103. The quantity indicator collapsed (Figure 104) as the bottom of the cell moved upward.

Figure 101. Posttest Bottom View of Left Fuel Cell.

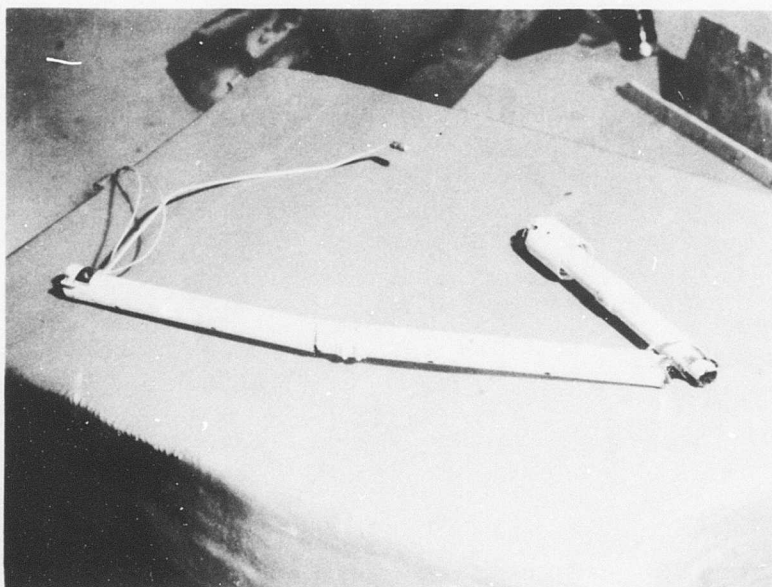
Figure 104. Fuel Quantity Indicator After Test.

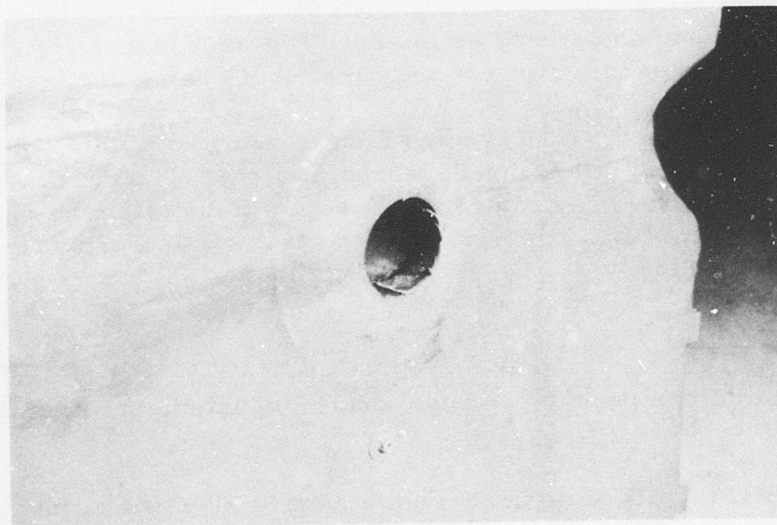
The self-sealing quick disconnect connecting the engine fuel line to the left cell did not separate, since there was adequate length to the line to preclude its being placed in tension. The frangible connector between the cell and cavity wall did separate as designed. The broken cavity wall attachment and the part of the connector that remained and displaced with

Figure 106. Remains of the Frangible Tank Wall Stabilizer Surrounding the Tank-to-Engine Tank Outlet.

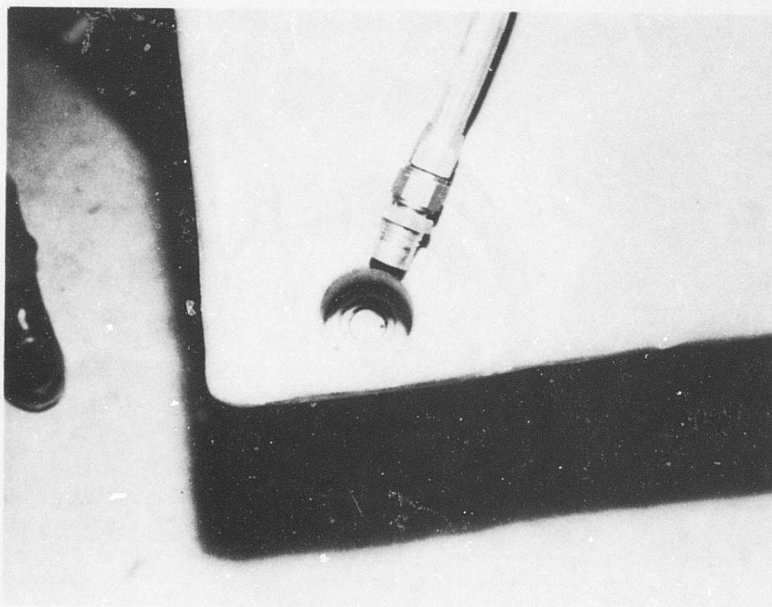
The forward crossover assembly was impacted near the self-sealing quick-disconnect connection to the left cell. The left disconnect separated from the cell and closed. The crossover disconnect connection to the right cell remained attached. There was no leakage from the assembly. All of the water in the left cell exited through the boost pump opening. Both self-sealing quick disconnects were still capable of functioning after the cells were removed from the fuselage section, as shown in Figures 107 and 108. The posttest condition of both crossover assemblies is shown in Figure 109.

Figure 108. Posttest Position of Breakaway Valve in Forward Crossover Attachment to Right Cell.

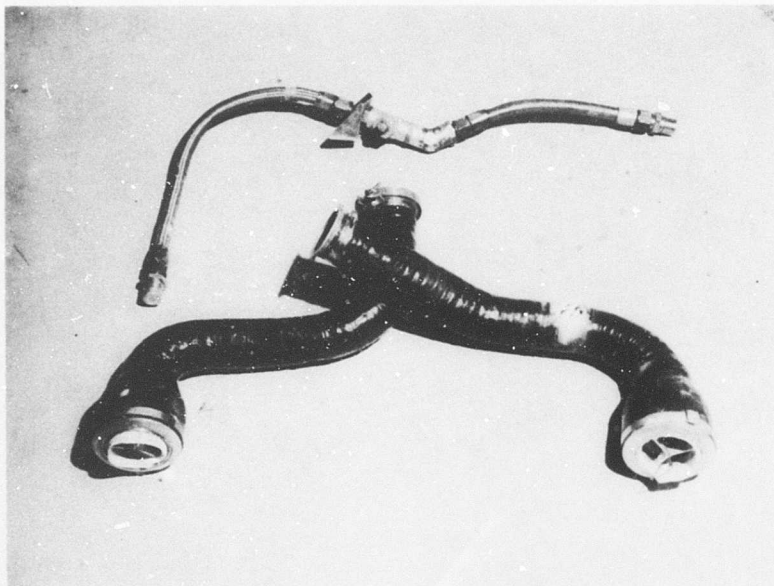
Figure 109. Forward and Aft Crossover Assemblies After the Test.

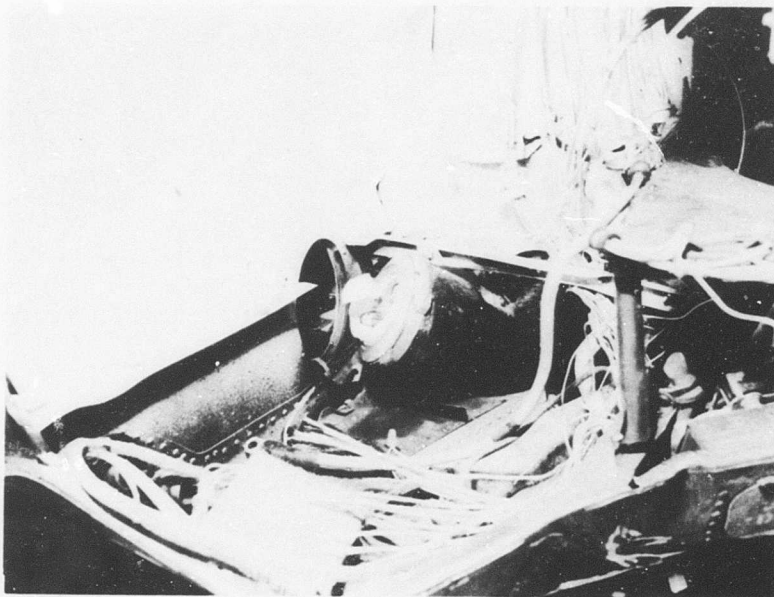
The aft crossover tube separated from each fuel cell at the self-sealing breakaway interconnect. The disconnects from the right and left cells are seen in Figures 110 and 111. The interconnect halves that remained in the cells closed and sealed as intended. Both interconnects in the crossover tube closed; however, only the right one sealed completely.

Figure 111. Aft Crossover Assembly Separation
From the Left Cell.

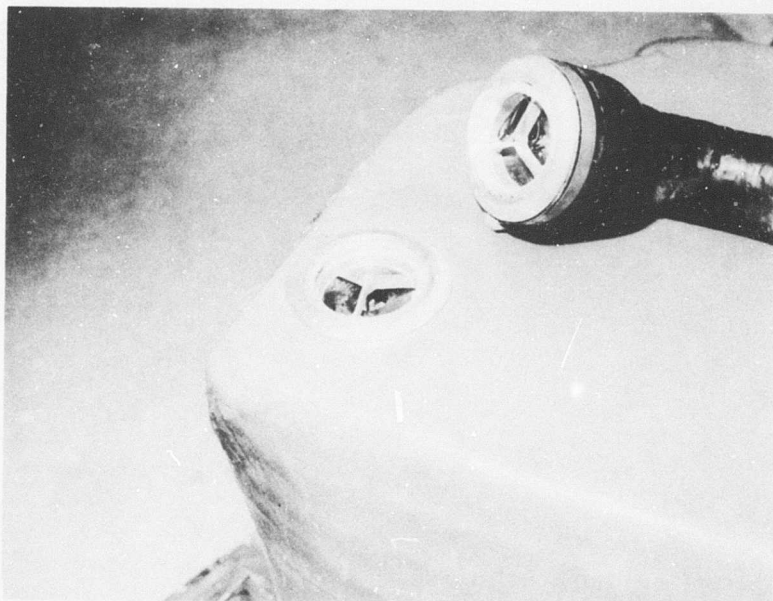
The left interconnect was prevented from sealing completely by a displaced O-ring. The interconnect leaked at a rate of approximately 1/2 pint per minute. The interconnect separations after the cells and the crossover had been removed from the test section are posed in Figures 112 and 113.

Figure 112. Breakaway Interconnect Separation -
Right Side.

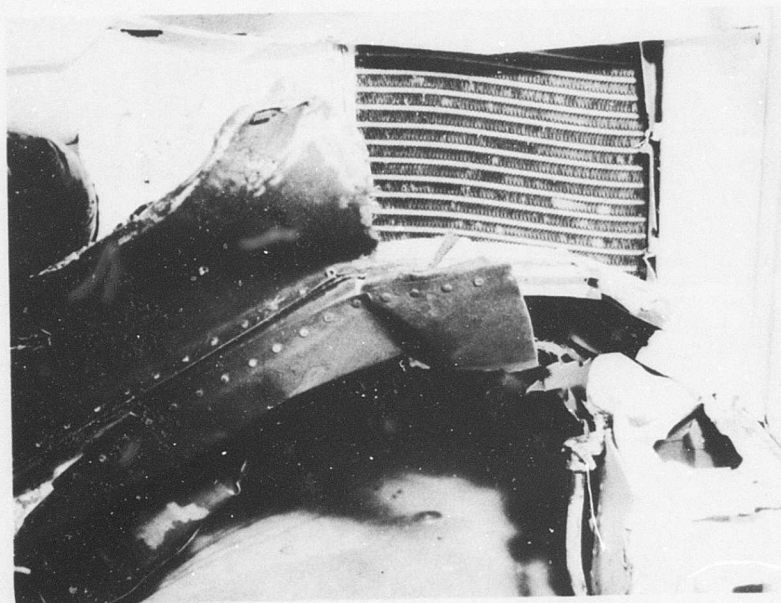
The bottom of the oil cooler received a severe blow. A front view of the cooler is shown in Figure 114. The cooler can barely be seen behind the fan, as shown in Figure 115, a rear view. Deformation caused by impact with the railroad tie on the bottom of the unit is shown in Figure 116.

Figure 114. Posttest Front View of Oil Cooler.

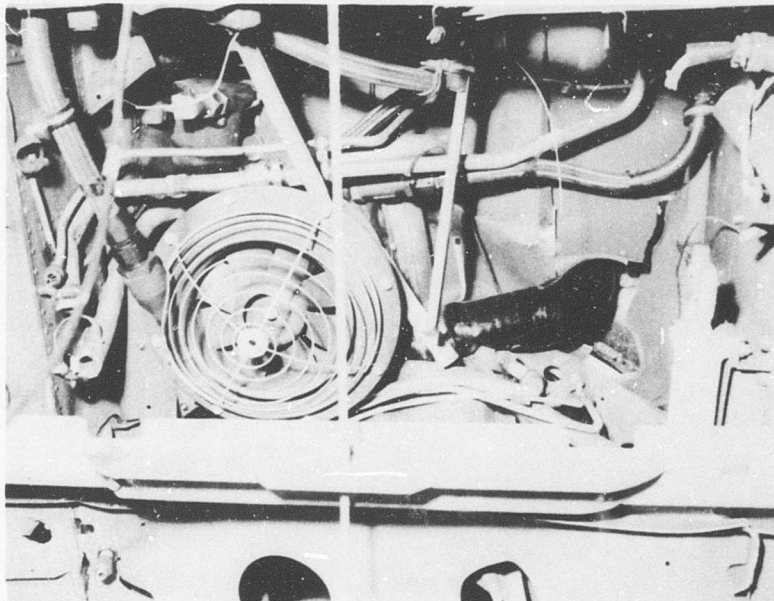
Figure 115. Posttest Rear View of Oil Cooler.
